# Girty's Run Flood Control Alternatives Analysis

Team: RRDA Consulting

4/15/19

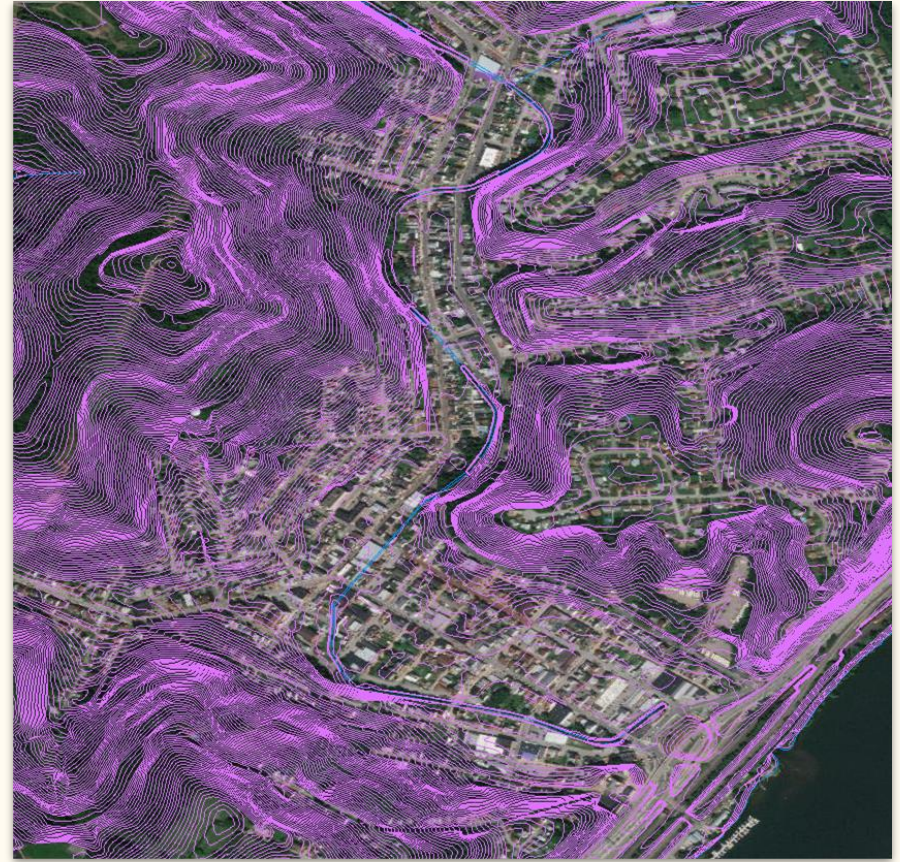
- Highest point: 910 ft msl
- Downtown Millvale: 700 ft msl
- Deep Valley
- Steep Walls
- Vulnerable Position
- Upstream conditions are similar

\*Contour Density Map created with ArcGIS

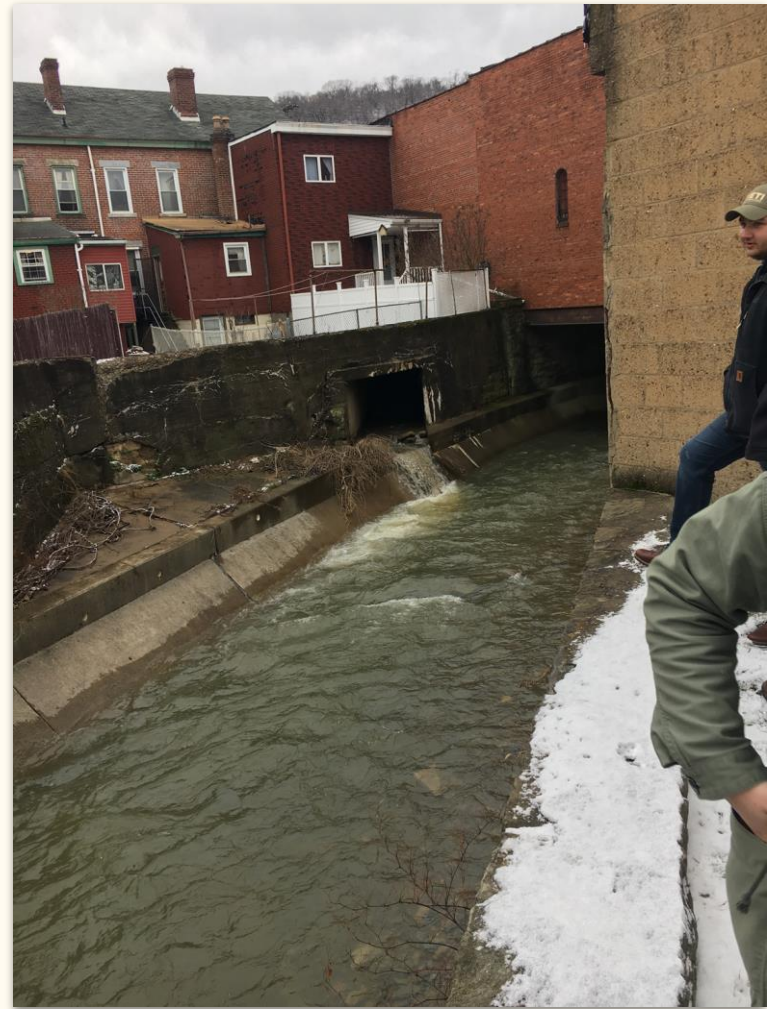
Right: Example of channel emerging from  
under buildings

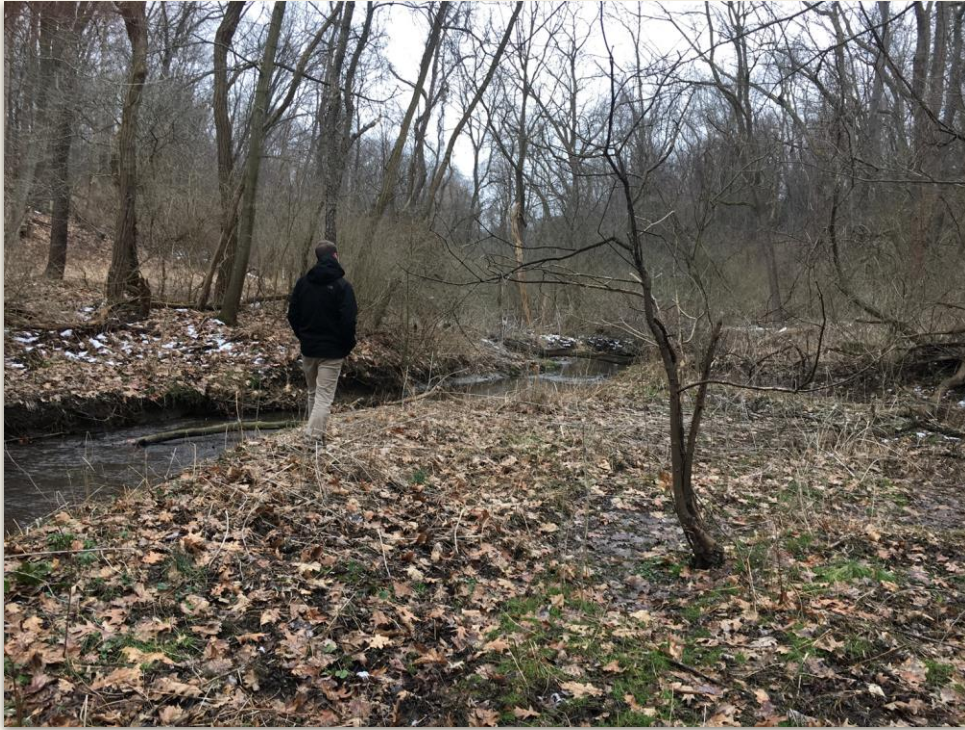
Top: Beginning of Girty's Run ~6mi upstream

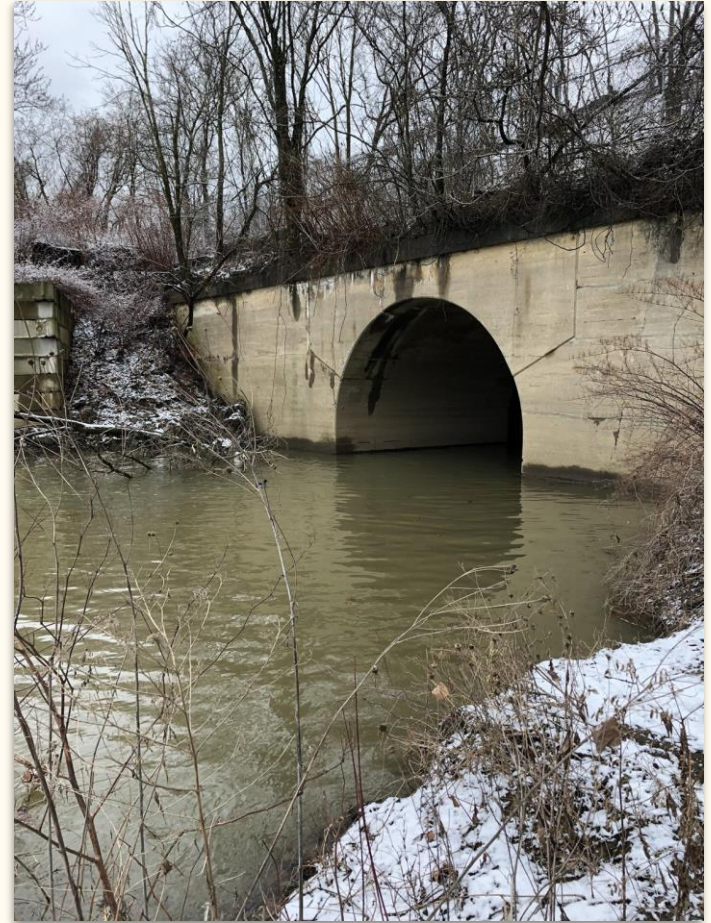
Right: Girty's Run outlet into Allegheny River

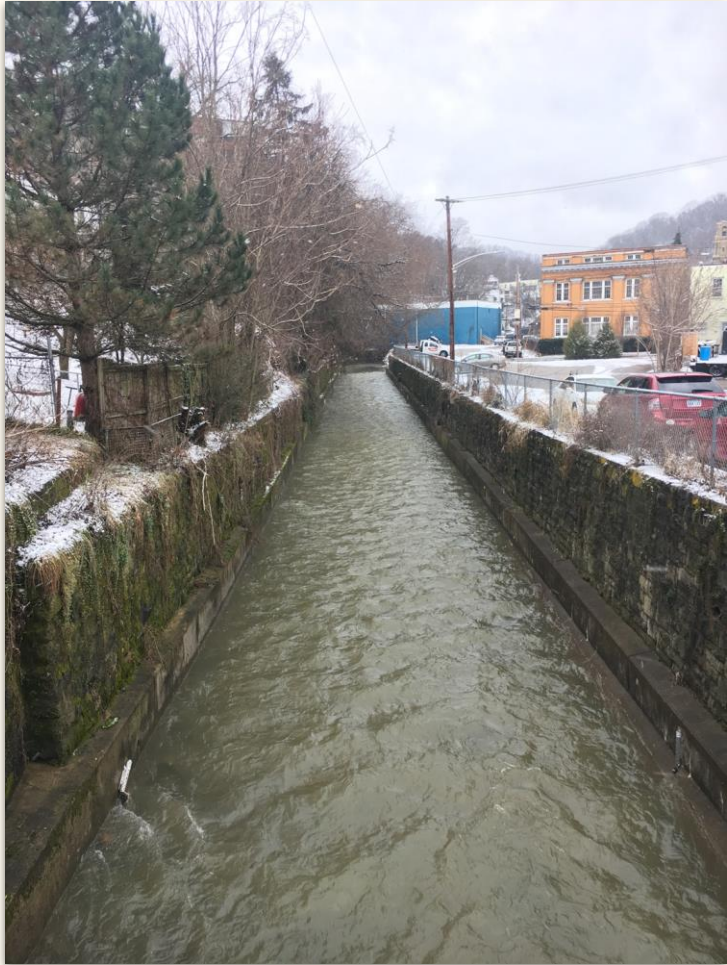
Left: Channel section through Millvale

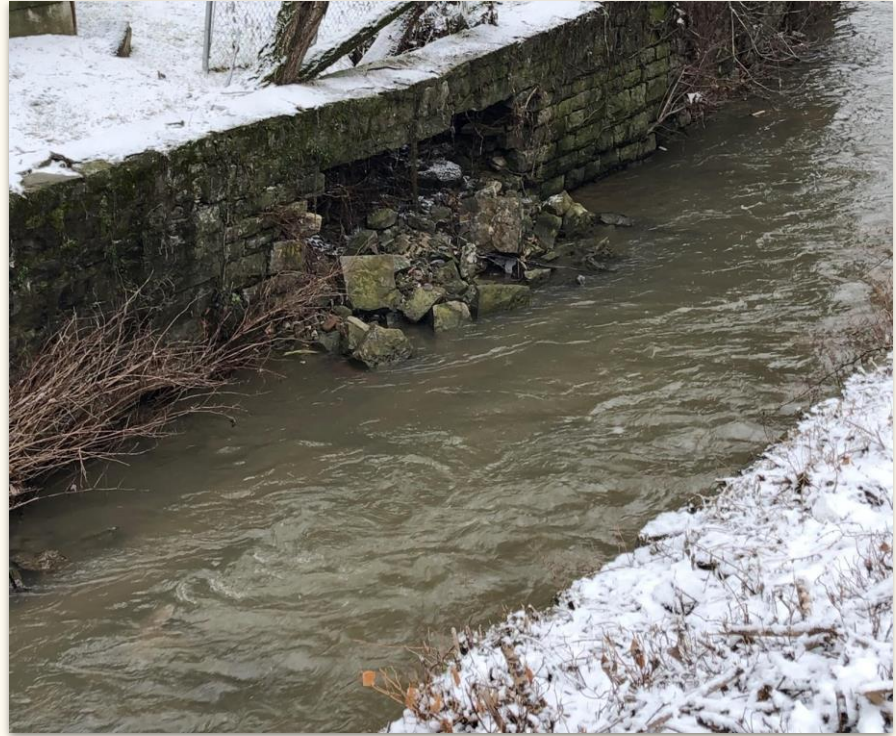
Right: Failed wall in channel

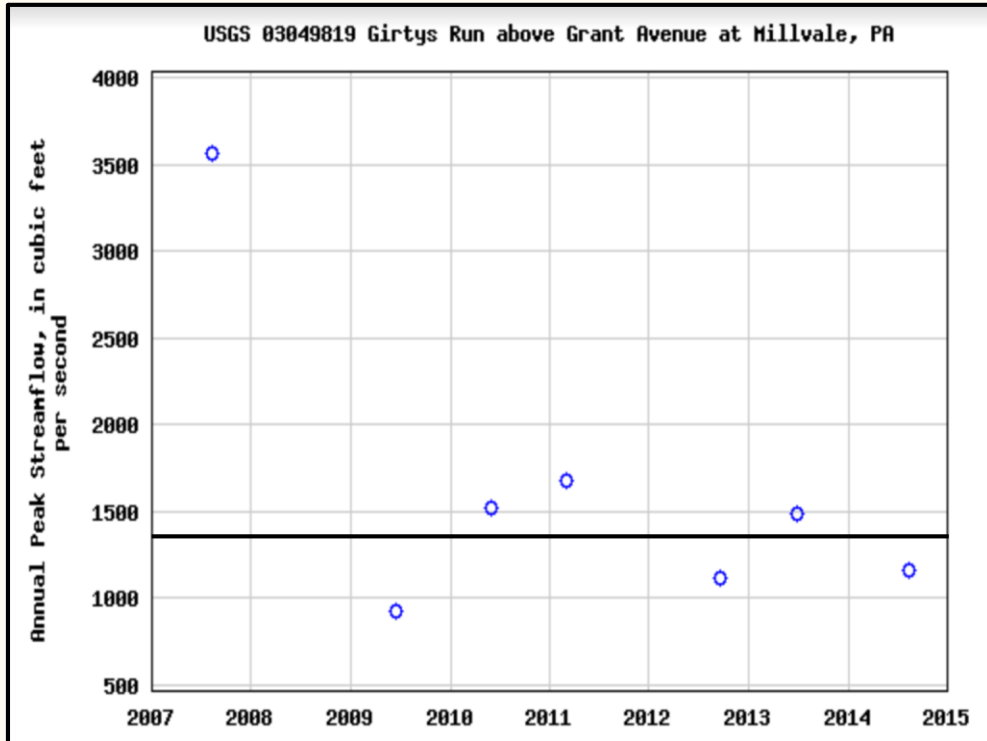
- Girty's Run overflows at 1400 cfs
  - (BLACK LINE - see figure)
- Overflows have occurred almost yearly within the past decade

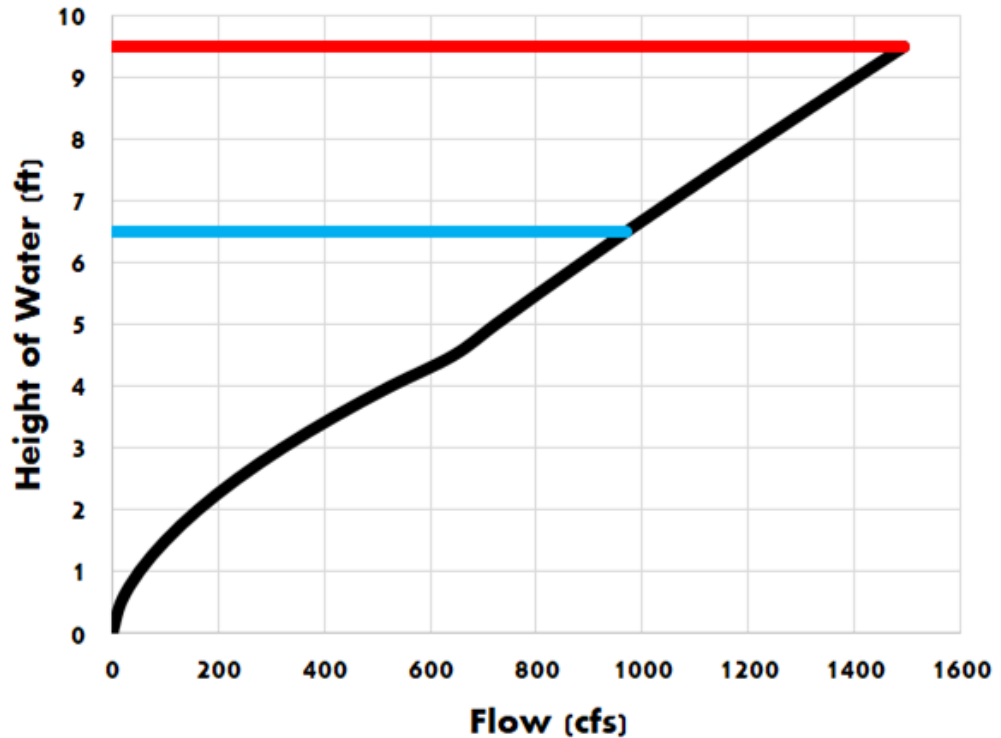
**Millvale - Girty's Run Rating Curve**

$$Q = VA = \left( \frac{1.49}{n} \right) AR^{\frac{2}{3}} \sqrt{S} \quad [\text{U.S.}]$$

Actual Water Depth: —————

Action Stage: —————

Flood Stage: —————

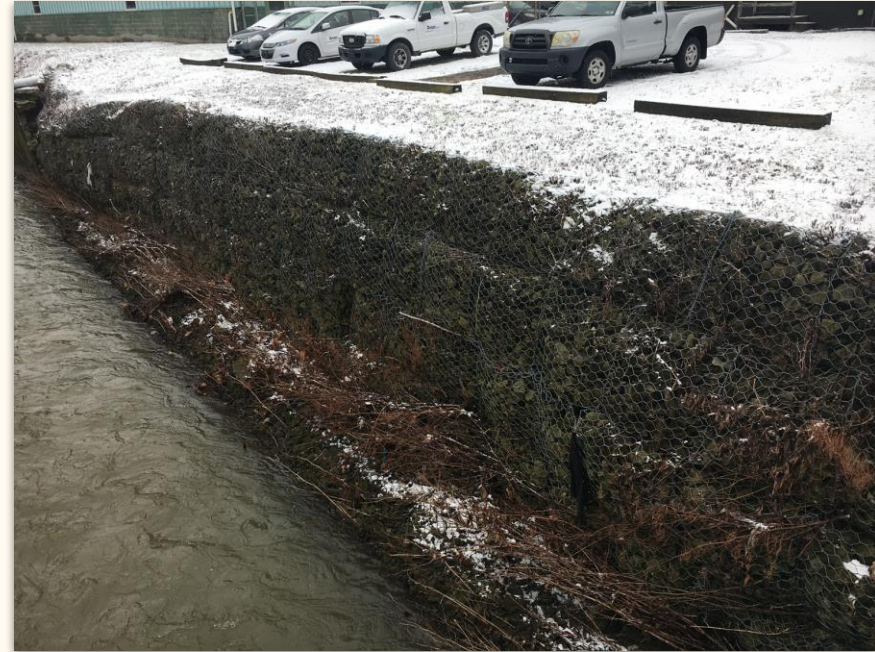
- Channel improvement completion (1980)
  - Deepened channel
  - Added gabions
- With no action
  - Channel Walls Failing
  - Channel continuously filling with sediment
- Decreased capacity of channel
  - Increased severity of floods
  - Increased frequency of floods

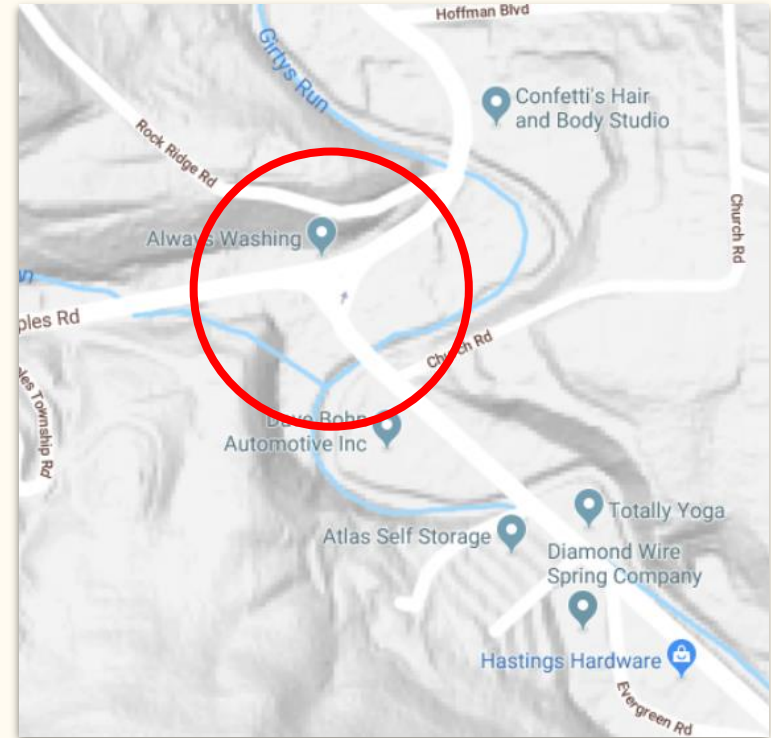
- Ross & Shaler Townships, North Hills Area
- Detention Pond(s) near Babcock Blvd
  - Large singular or series of system(s)
  - Contains critical points near Girty's run
- Presence of large cliffs
  - Excess of 70 feet
  - Not feasible to place detention ponds

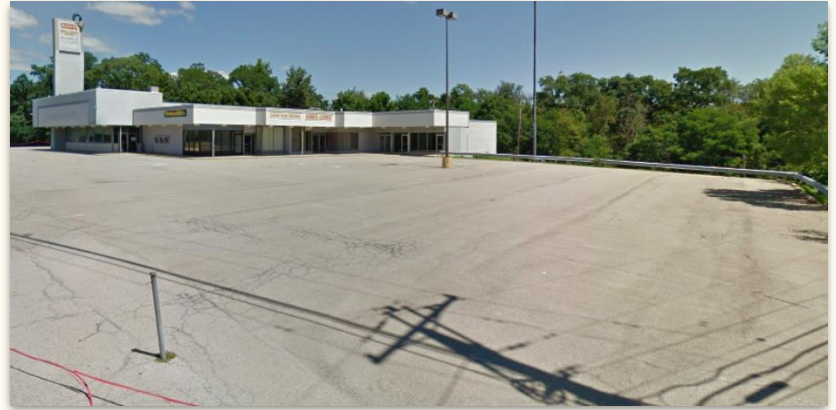
- Designing in accordance with the Pennsylvania Stormwater BMP Manual
  - Using the rational formula
  - 2 year storm event

$$Q_{\text{Post}} = (1.18 \text{ in/hr}) * (0.9) * (7.2 \text{ acres}) - Q_{\text{Pre}}$$

$$Q_{\text{Post}} = 6 \text{ cfs}$$

- Impactful peak discharge reduction requires much larger catchment area

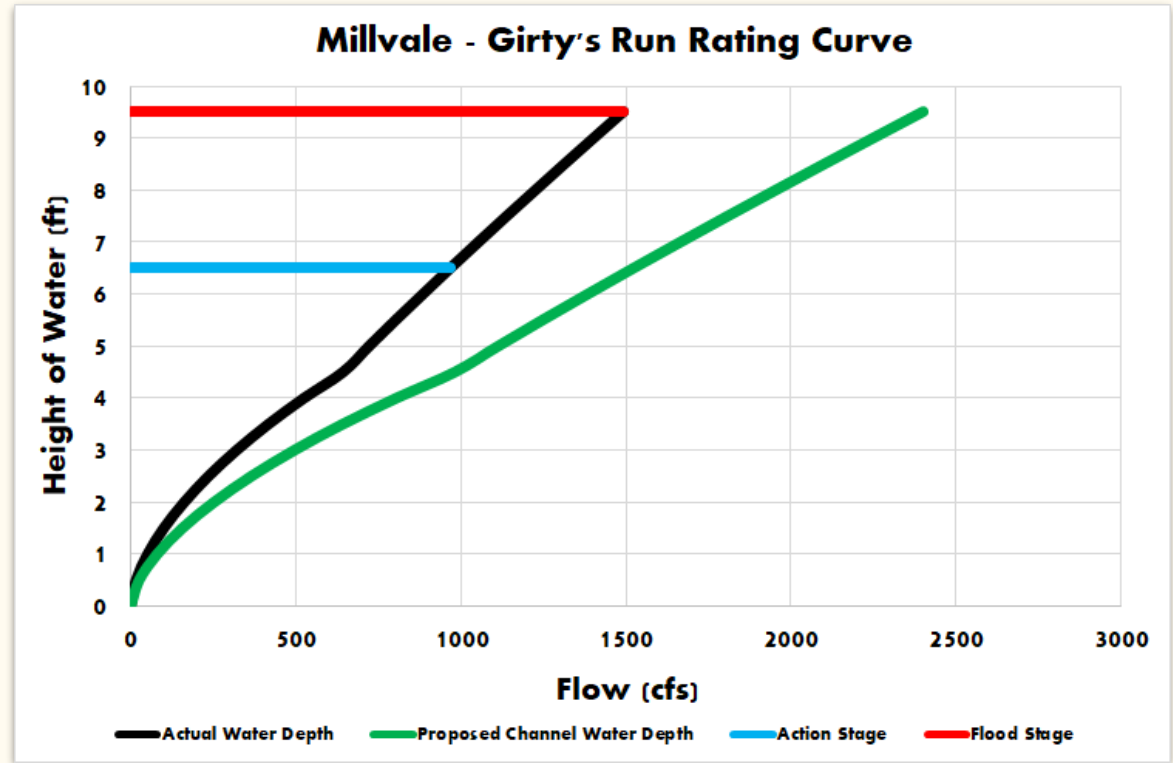
- Flood Stage (9.5ft)
  - Before: 1400 cfs
  - After: 2400 cfs
  - 71% Increase
- Action Stage (6.5 ft)
  - Before: 1000 cfs
  - After: 1500 cfs
  - 50% increase

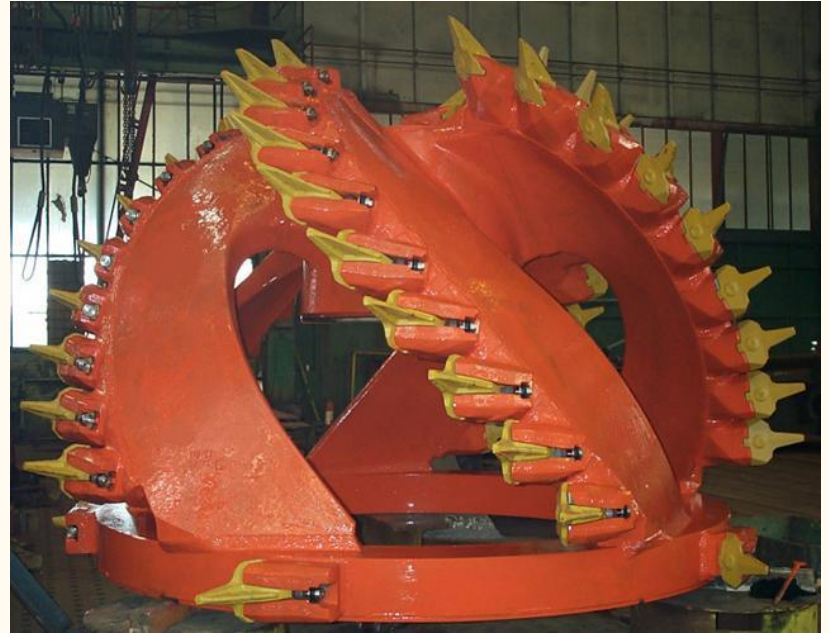
- Methods
  - Cutterhead pipeline dredges
  - Mechanical dredges
- Resulting in increased channel capacity
  - Average of 2.5 feet of sediment build up
  - Stage height increase of 1.5 feet
  - Additional 350 cfs of capacity during flood stage

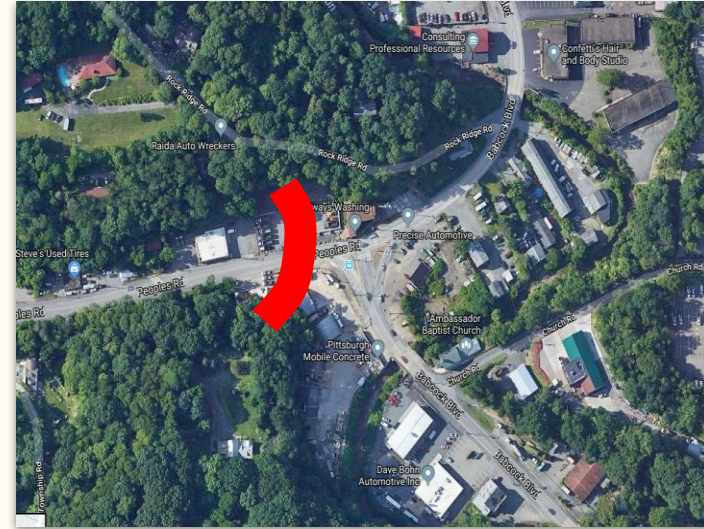
- Designed by Army Corps of Engineers in 1970
  - Location: Intersection of Evergreen Rd and Babcock Blvd
  - Height: 115 ft Length: 1000 ft
  - Earthen Dam
  - Create a lake of 100 acres
    - Providing 3140 ac-ft of Storage
    - Provide flood mitigation
- Issues
  - Residences and commercial structures
  - Highway relocation

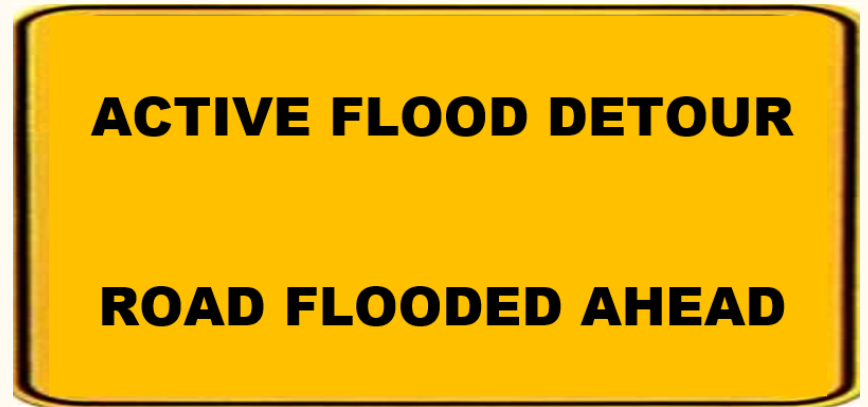
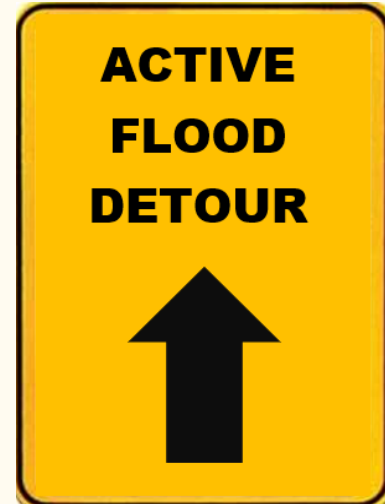
- Allow safe travels around Millvale
- Sign Type
  - Variable
  - Temporary
    - Signs placed during emergency management plan

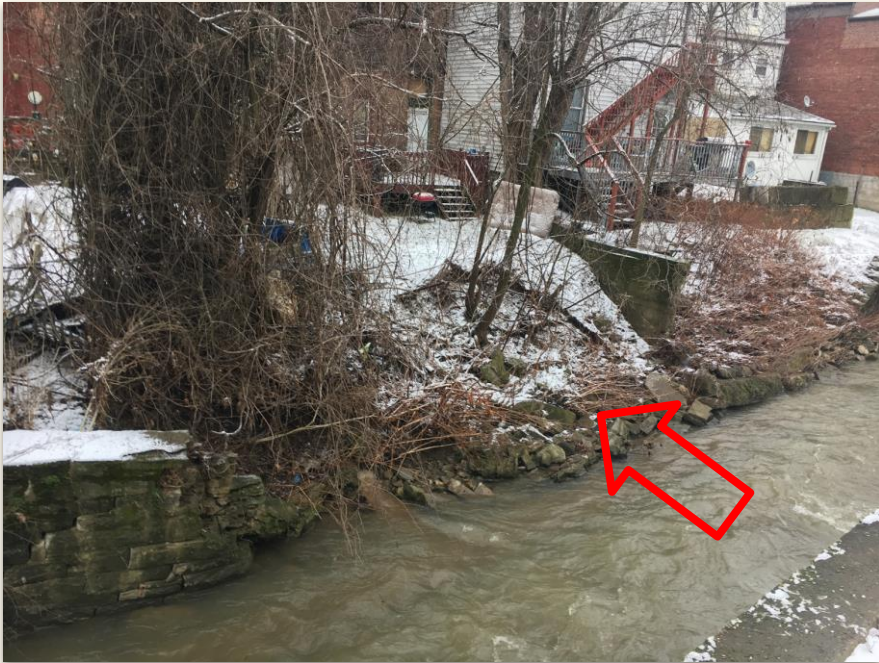
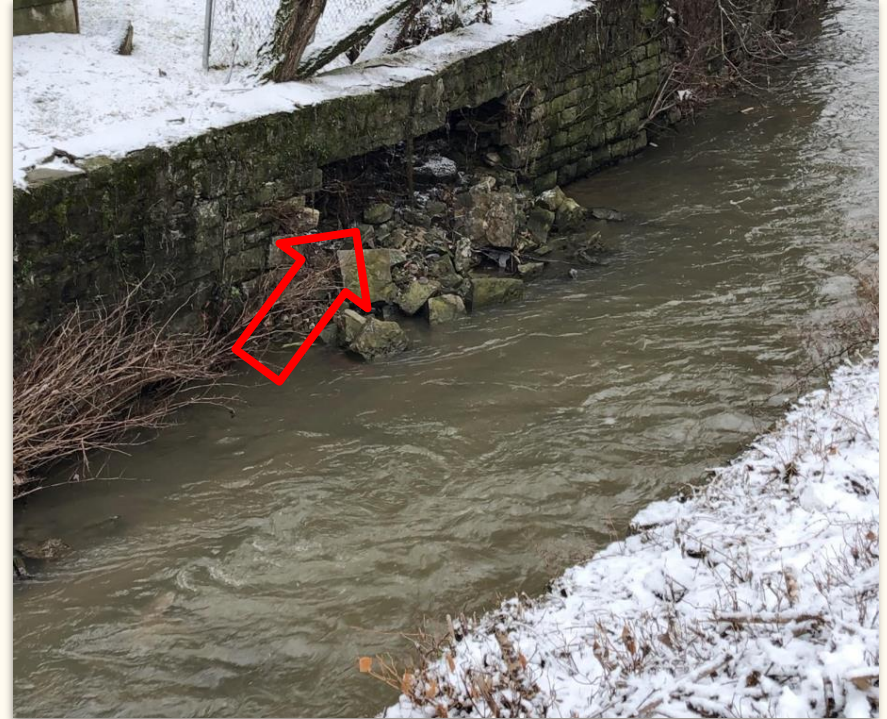
- Field Identified areas of concern

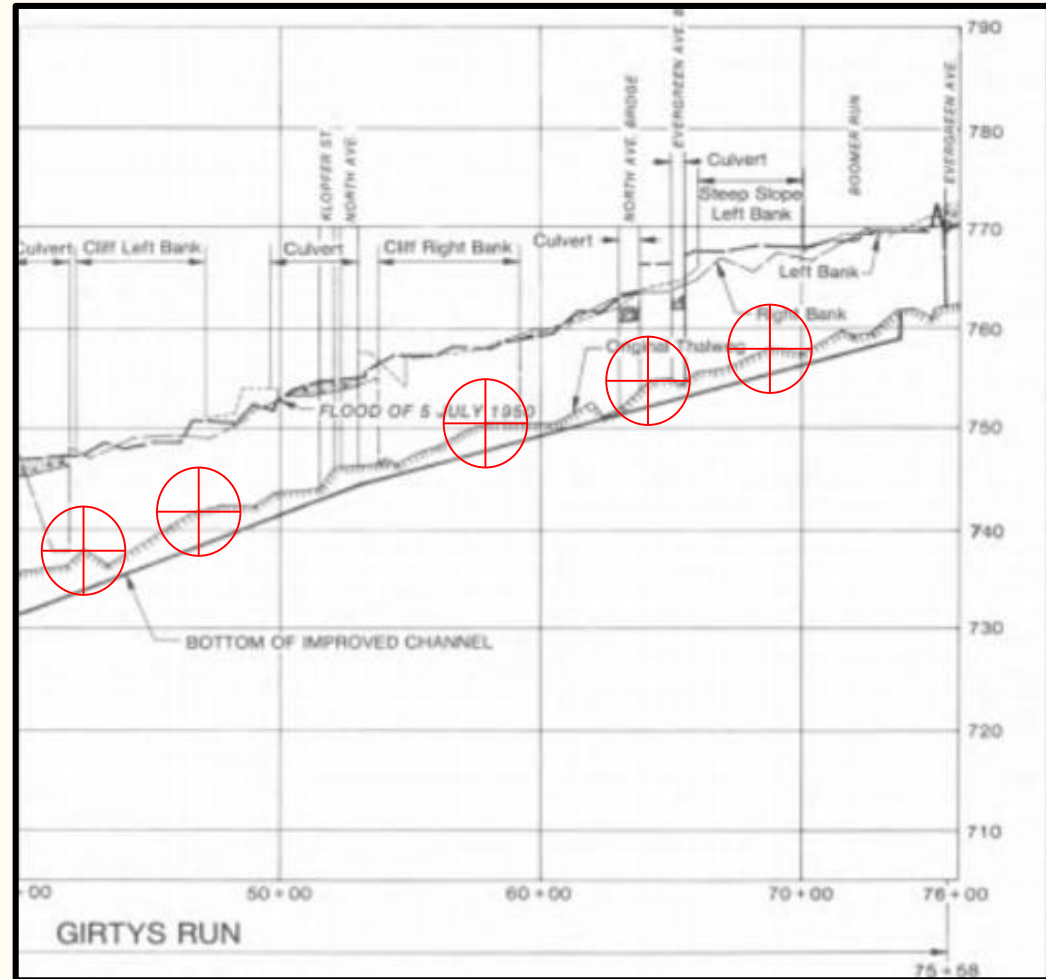
- From Evergreen Ave to 50 ft before Fremont St
- 18,750 ft<sup>3</sup> of silt accumulated
- Average silt build-up of 1 ft
- Several areas warrant concern

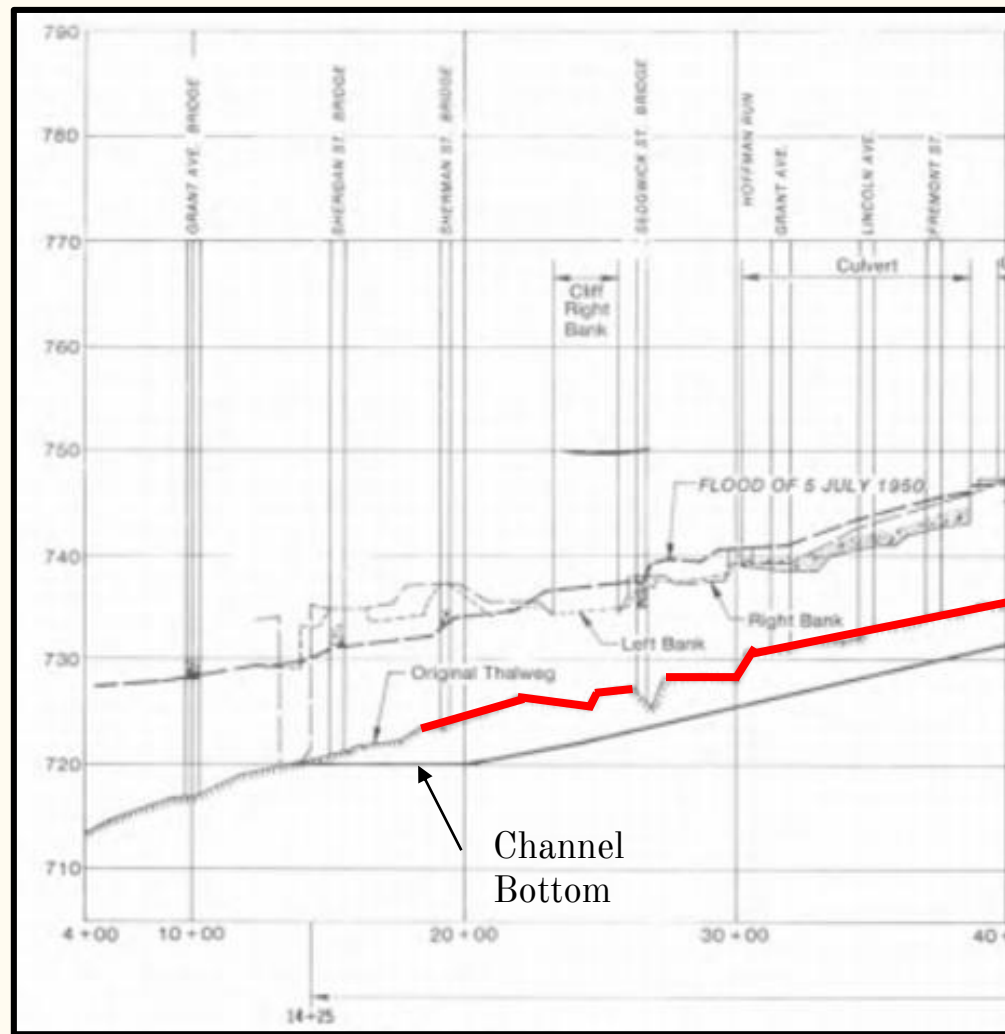
- 20 ft before Fremont St to Sheridan St
- 26,250 ft<sup>3</sup> of silt accumulated
- Average silt build-up of 2 ft
- Primary target for dredging

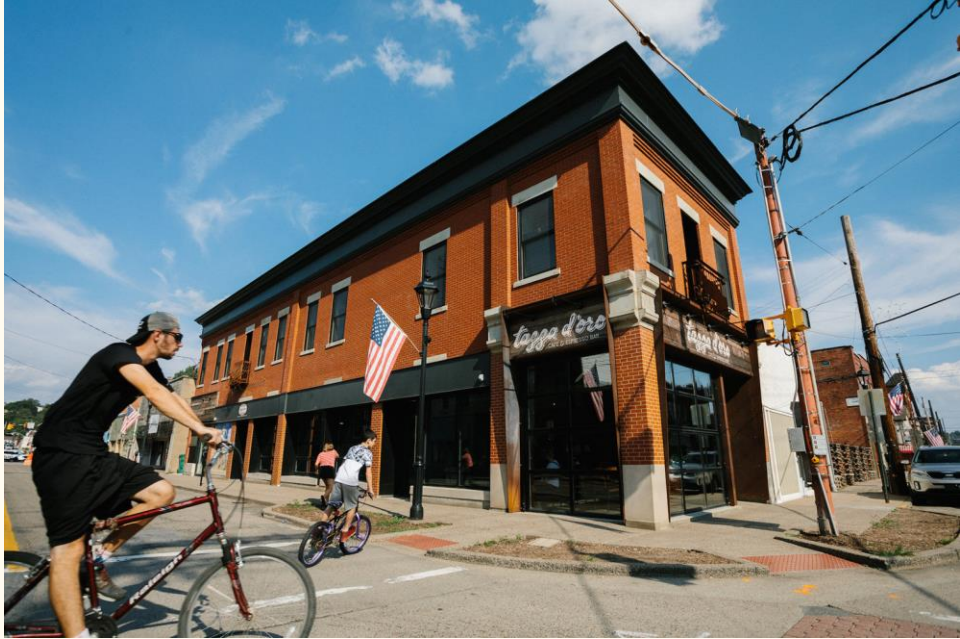
- Grant Ave:
  - Street Width = 32 ft
  - Sidewalk Width = 9 ft
- North Ave:
  - Street Width = 32.5 ft
  - Sidewalk Width = 9 ft
- Single Pour Concrete Sidewalks
- ADA Compliant Crosswalks

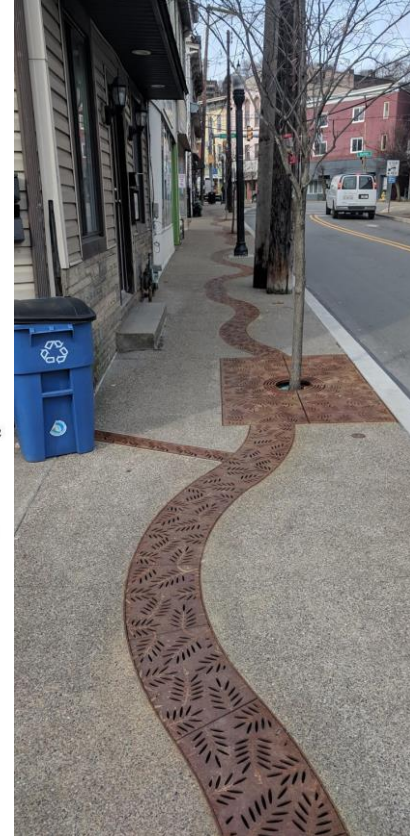
- Improved Sidewalk Drain Network
- Street Trees
- Downspout Disconnections
- Rain Gardens

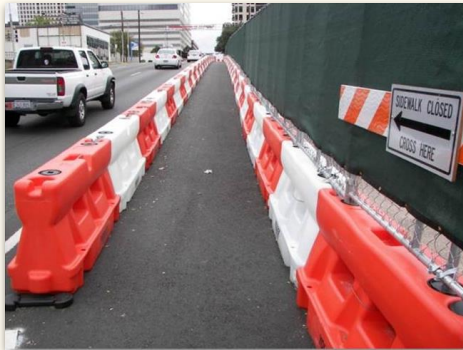
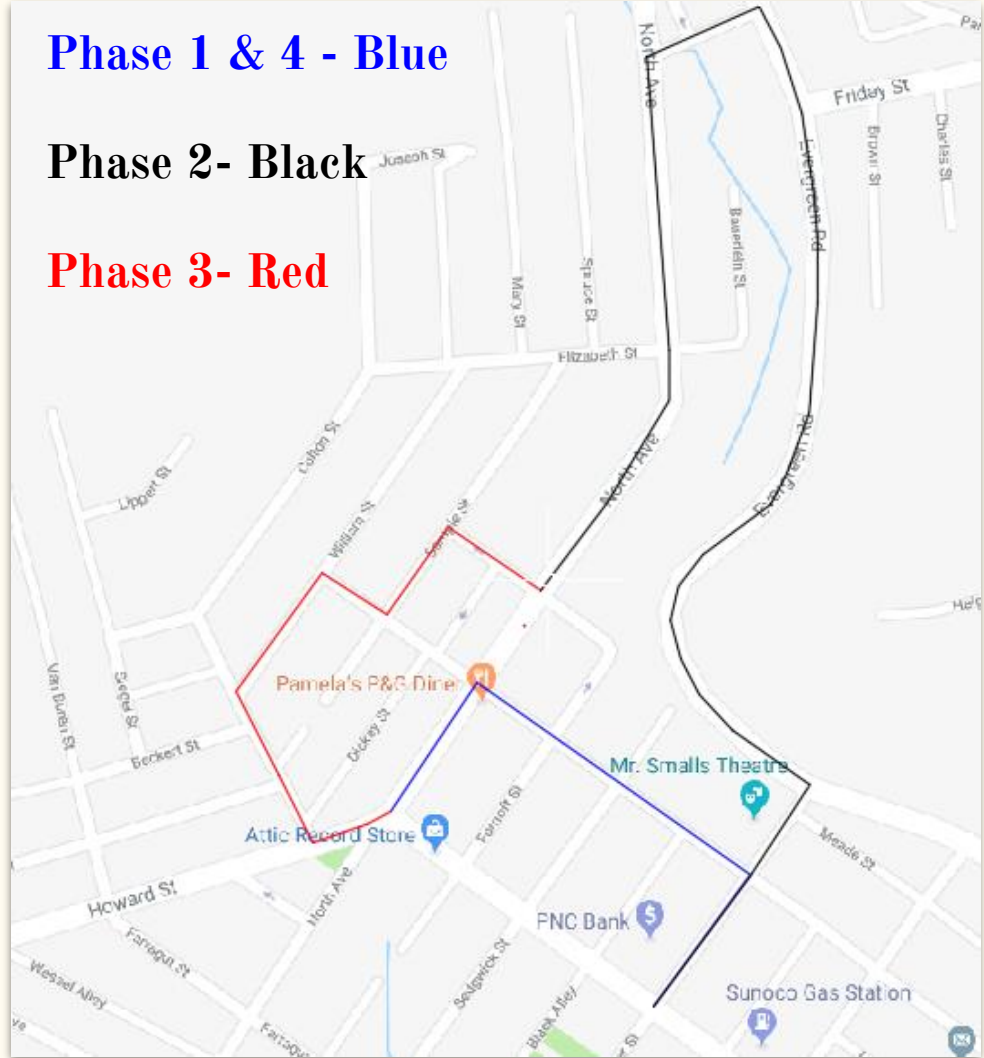
- 2 travel lanes and 2 parking lanes
- Closed parking lane on side closest to construction
  - Staging area
- Closed travel lane on side closest to construction
  - Temporary walkway for pedestrians
  - Barrier protection
